April 1, 2022

Re: Unsafe Structure
Bayview 60
3800 N.E. 168th Street
North Miami Beach, Florida 33160

CEILING ELEVATION PTS. - 2ND FLOOR (3-A SLAB)

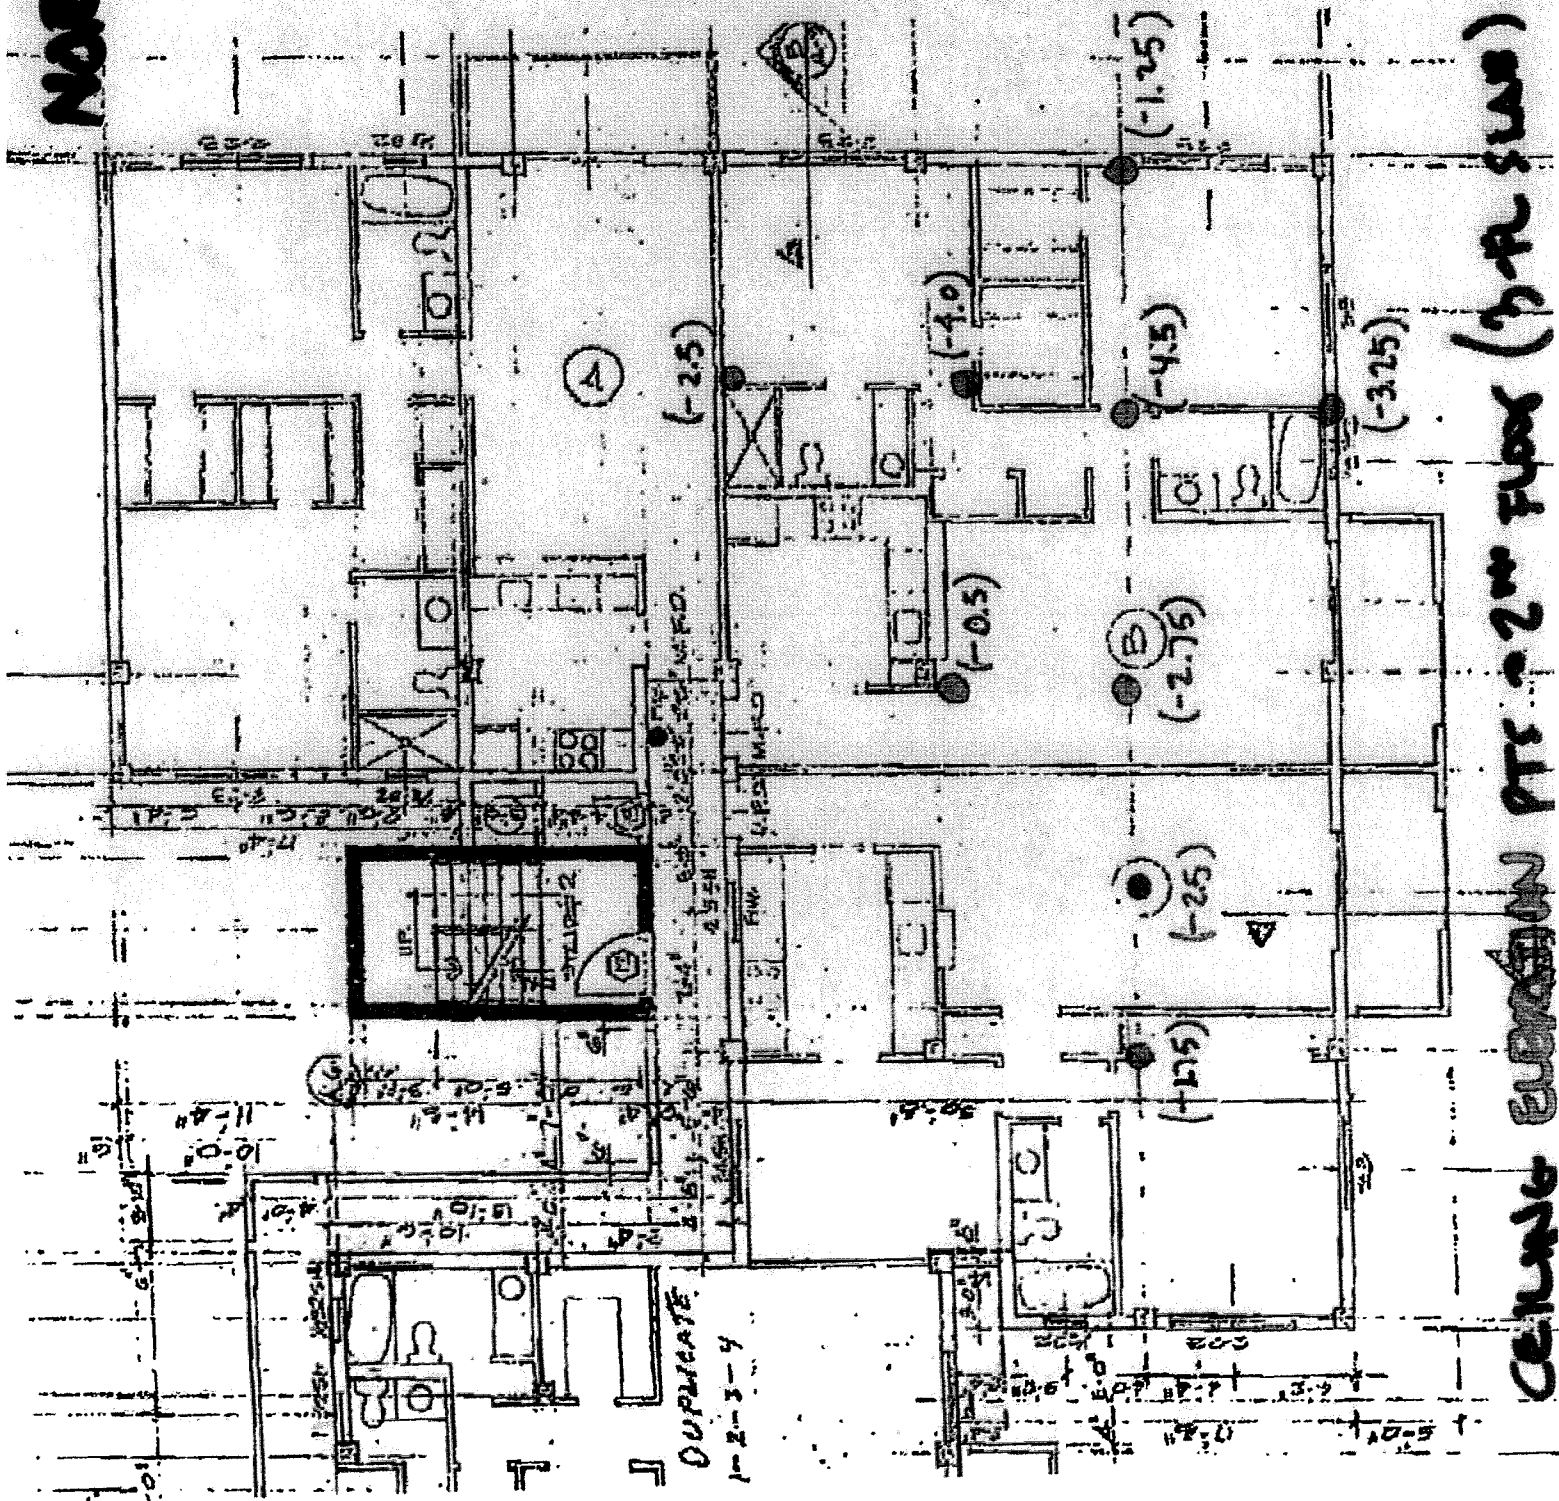
I am writing you today to notify you of our most recent findings after months of investigation in an attempt to restore the structural integrity of the structure. I have enclosed a copy of the elevation points taken this morning by the general contractor. After careful review of this data the deflection in the slabs is exceeding the ACI guidelines for two-way slabs.

- Bottom of 3rd floor slab relative elevation points (taken inside 2nd floor unit)
- Bottom of 2nd floor slab relative elevation points – east end of building (taken at garage level)
- Bottom of 2nd floor slab relative elevation points – west end of building (taken at garage level)

As before, we did not scrape the finishes to reach the actual structure, so we'd say these measurements are $\pm 1/4$ -inches.

Therefore, it is my responsibility to inform you that the building structure is structurally unsound and must be evacuated immediately.
